No Net Loss of Fish Habitat: An Audit of Forest Road Crossings of Fish-Bearing Streams in British Columbia, 1996-1999

D.J. Harper and J.T. Quigley

**Canadian Technical Report of
Fisheries and Aquatic Sciences 2319**

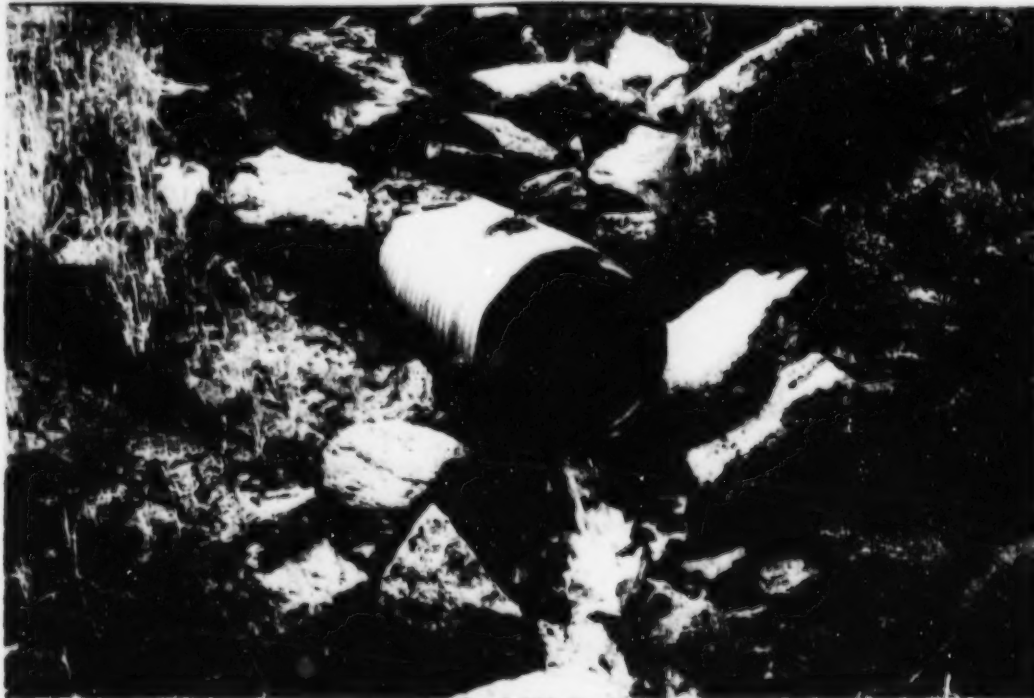
The total stream habitat loss (habitat loss due to encroachment plus benthic loss) totalled 562 m² in the PGFD (n=23) compared to 110.3 m² in the PMFD (n=23). In the PGFD, 70% of the crossings resulted in a habitat loss due to encroachment and 52% of the crossings caused a benthic loss. Only 26% of the crossings in the PMFD resulted in a habitat loss due to encroachment, and none of the crossings resulted in a benthic loss. The loss of stream habitat in the PGFD was greater than that of the PMFD due to the fact that 100% of the CMPs installed in the PGFD encroached on their respective channels and none of them were embedded (see photographs 1 & 2 in Appendix 2).

Photograph 1. Stream crossing PG2-2. The 0.750 m wide post-FPC CMP was only 22% of the width of the bankful width of the stream channel (3.45 m). This resulted in a velocity barrier and an outlet barrier.

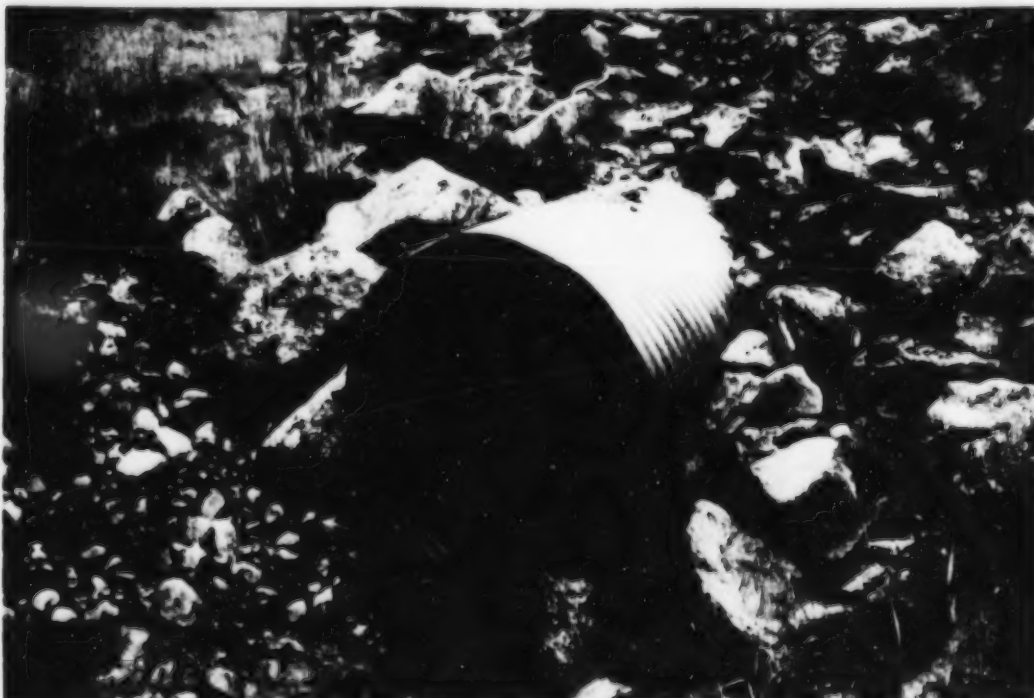
Photograph 2. Inlet of culvert at stream crossing PG2-1. The crossing width was only 29% of the channel width. Note that the ditchline flows directly into the creek.

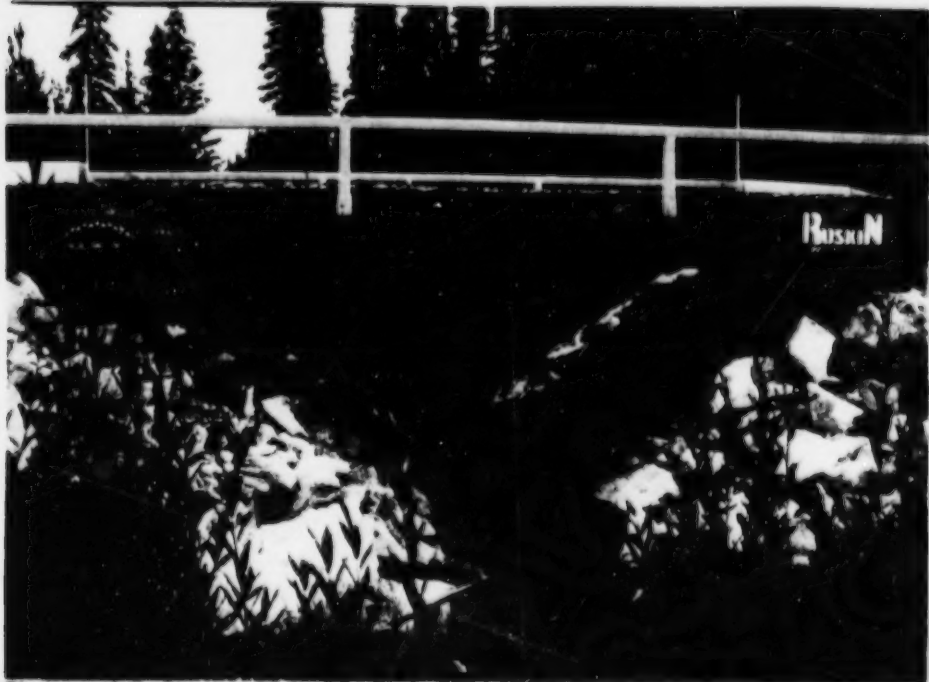
Photograph 5. Stream crossing PG1-3. Note the excessive rip-rap placed on the streambanks. The crossing width was only 51% of the stream channel.

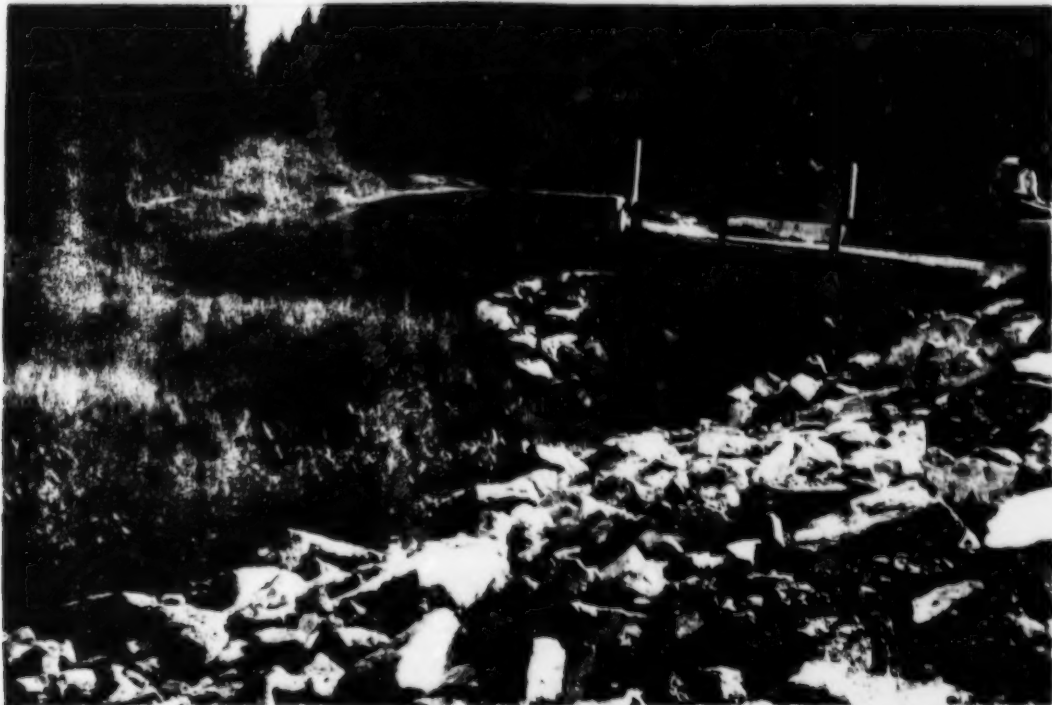
Photograph 7. Stream Crossing PG1-5. Note the excessive rip-rap placement in foreground and corresponding permanent loss of riparian vegetation.
